# ESTCP Cost and Performance Report

## Field Demonstration of a Novel Biotreatment Process for Perchlorate Reduction in Groundwater

December 2010

Project: ER-200636

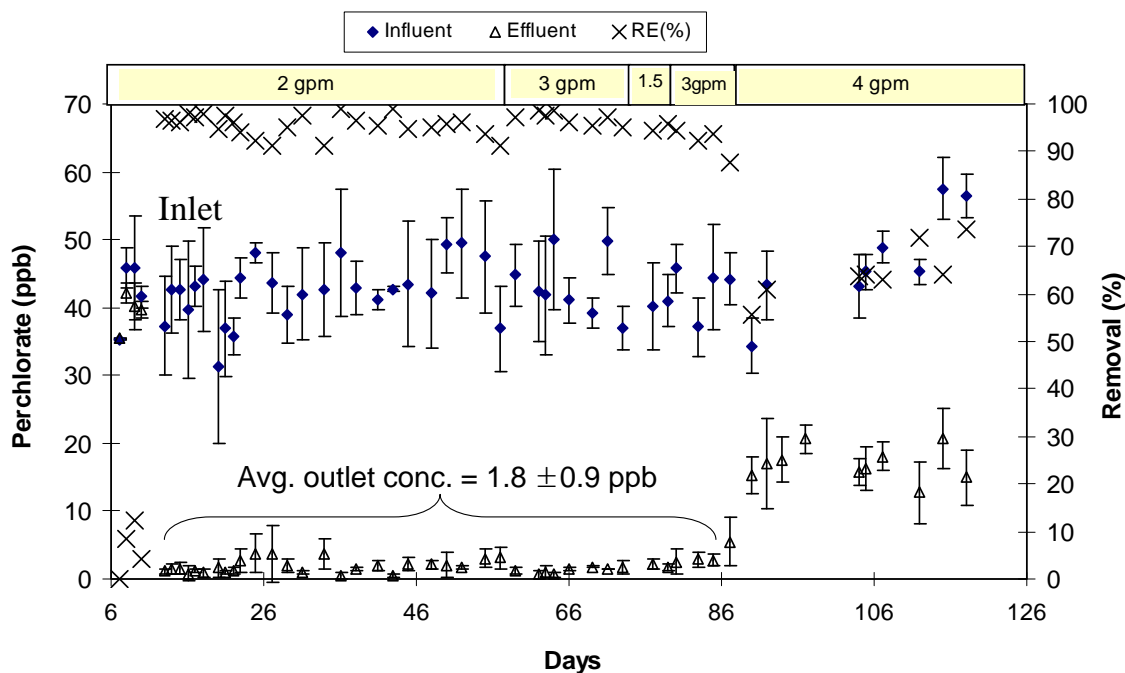
**Figure 5. Perchlorate inlet and outlet concentrations over the first 4 months of operation.**

After about 80 days of operation, before the water flow rate could be increased to test treatment performance at its nominal capacity, perchlorate removal performance deteriorated. Within about a week, the outlet perchlorate concentration increased to 12-18 ppb (see Figure 5), corresponding to a removal of 60-70% only, and nitrate removal steadily decreased. The reactor upset was unexpected as we ran biotreatment systems in the laboratory for over 2 years without a problem. The loss in treatment performance could not be traced back to any outside event (power failure, visible symptom, etc.). Thus, several hypotheses were formulated in an attempt to explain the

loss in treatment efficacy, and they were systematically tested. Various attempts were made to recover full treatment capacity, but all failed.

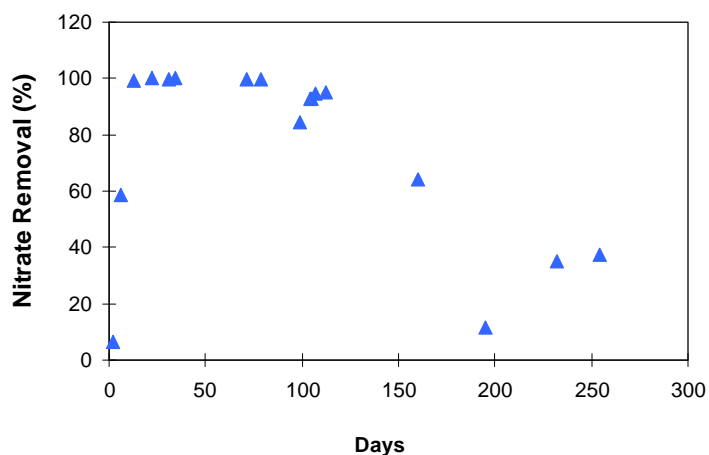
**Figure 6. Nitrate removal over the duration of the field demonstration.**

After approximately 3 months of operation, perchlorate and nitrate removal began to deteriorate, with less than 40% perchlorate and nitrate removal for the remaining 5 months of testing. This was unexpected as laboratory bioreactors ran over 2 years without a problem. Several hypotheses for the loss in treatment efficacy were tested. These included a severe reduction of the ZVI bed hydraulic conductivity, loss of perchlorate-reducing bacteria or of biological activity, or loss in iron reactivity. Various attempts were made to recover full treatment capacity, but all failed and full treatment capacity was never recovered. The most likely explanation to the reactor upset was a loss of hydraulic conductivity, although it is likely that biological factors and iron reactivity also played a role.

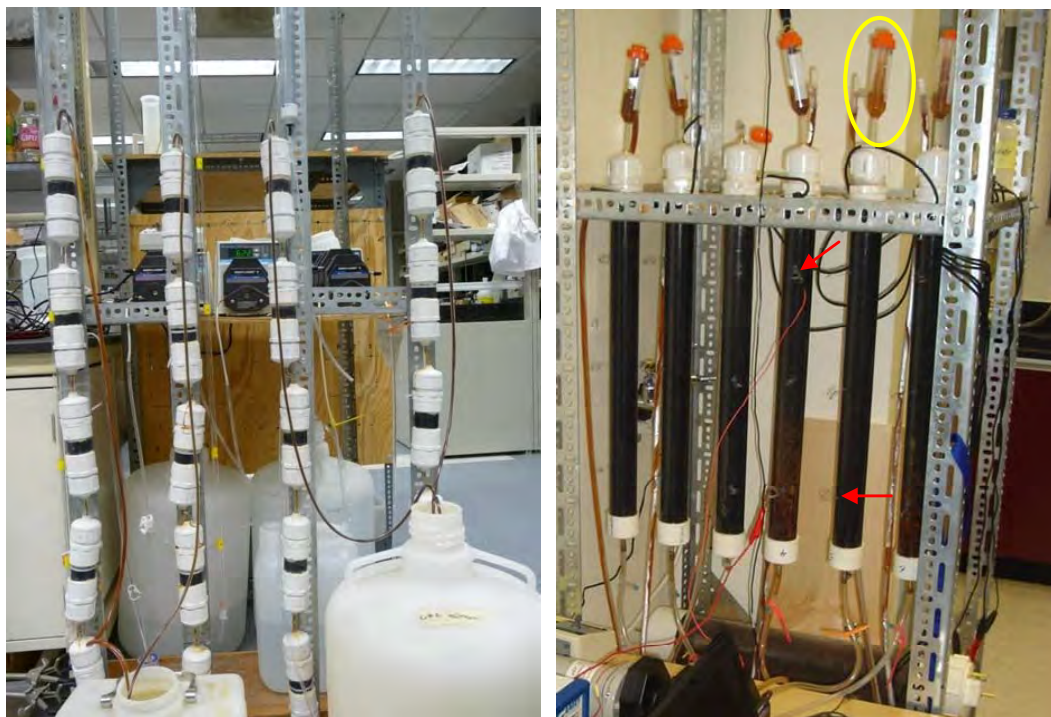
**Figure 8. Pictures of the laboratory column setups.**

One series of experiments determined that water high flow through the ZVI reactor was probably not a factor in the failure. However, a two to four order of magnitude loss hydraulic conductivity was observed shortly after water amended with  $\text{NaHCO}_3$  was fed to ZVI packed beds. The loss of hydraulic conductivity was most severe in units that received water with higher alkalinity. Visual observation, electronic microscopy and energy-dispersive X-ray analysis of ZVI and ZVI surfaces used in these reactors revealed that a variety of iron corrosion products (carbonate green rusts, iron [hydr]oxide, siderite [ $\text{FeCO}_3$ ]) and precipitates (mainly calcium carbonate) had formed in significant amounts that could explain the loss in hydraulic conductivity and possibly iron passivation. Separate experiments considered the role of DO, ZVI mesh size and various ions in the water undergoing treatment on porosity losses. Columns packed with fine ZVI and operated with high DO and  $20 \text{ mg L}^{-1}$  nitrate experienced rapid hydraulic problems leading to plugging. This was not the case with a column packed with fine ZVI and fed low DO deionized water. Some changes in porosity and hydraulic properties were observed in columns packed with coarse ZVI, but despite operation for close to 100 days, no condition led to bed plugging. These led to the conclusion that probably not a single factor was responsible for the failure of the demonstration unit. Instead, a combination of adverse conditions, with perhaps design and operating choices (nature of pretreatment, low water flow), were probably responsible for the failure of the bioreactor in the field.
